NUMBER: 18-035-08

MIL Illumination Due to P2000, P2A00 and/or P2A01

2007 - 2008 (DH/D1) Ram Truck 2500/3500

NOTE: This bulletin applies to vehicles equipped with a 6.7L Cummins diesel engine (sales code ETJ).

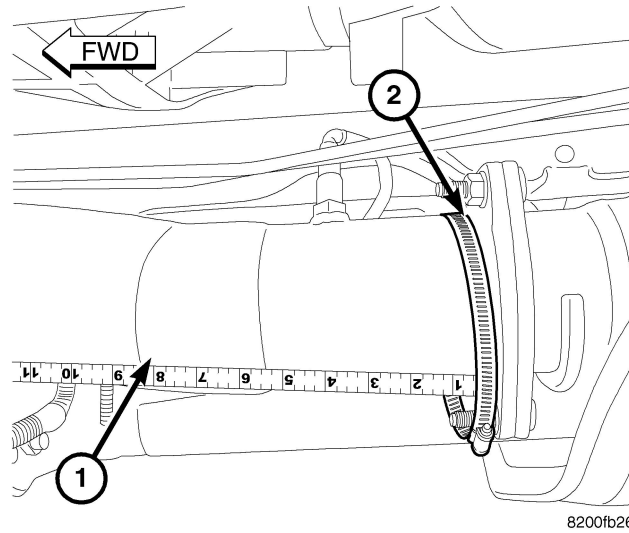
Fig. 1 MEASURE 7" FORWARD FROM FLANGE

- 1 - MARK 7" (17.75 cm) IN FRONT OF DOC-TO-NAC FLANGE
 - 2 - REAR BAND CLAMP LOOSELY INSTALLED
-

3. Locate the Diesel Oxidation Catalyst (DOC) downpipe to NOx Absorber Catalyst (NAC) flange. Measure and mark a line at a distance of 7" (18 cm) in front of this flange ([Fig. 1](#)).

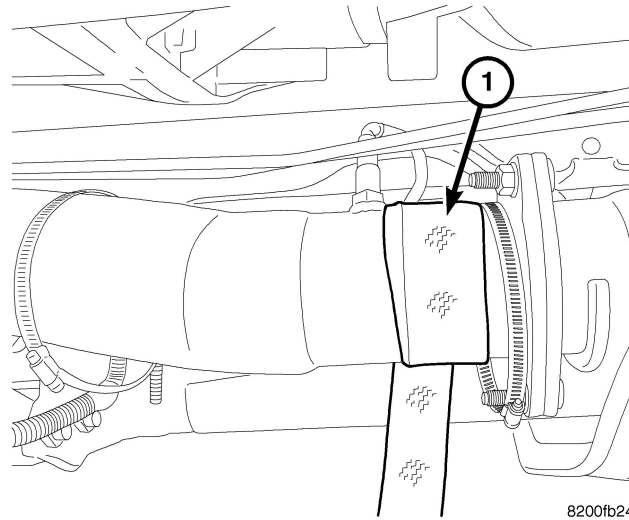
Fig. 2 FIRST WRAP IN FRONT OF FLANGE

1 - START 1" (25 mm) FROM FLANGE

5. Starting about 1" (25 mm) in front of the (DOC)-to-(NAC) flange and using full overlap, wrap insulation once around the exhaust pipe ([Fig. 2](#)).

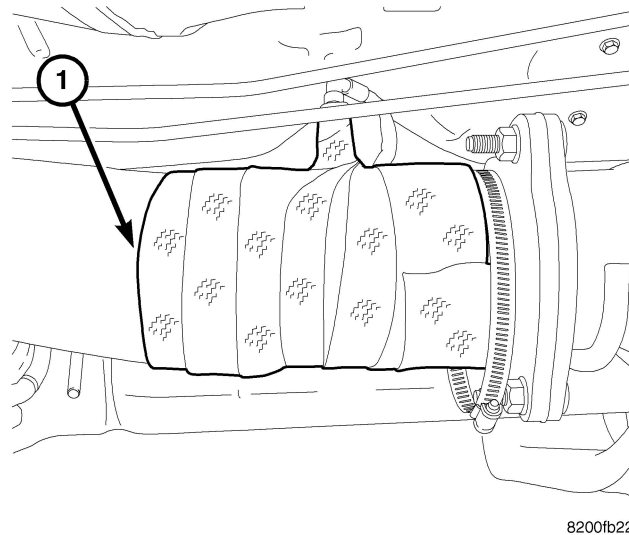
Fig. 3 WRAP COMPLETED

1 - WRAPPED FORWARD 7" (17.75 cm) FROM FLANGE AND BACK TO FLANGE

-
6. Wrap pipe in an upstream direction (toward O2 sensor) using a 1" (25 mm) over lap. Wrap to the O2 sensor. Wrap the body of the O2 sensor two times.
 7. Then continue wrapping the exhaust pipe in an upstream direction to the 7" (17.75 cm) mark established in [Step #3](#).
 8. Now continue the exhaust pipe wrap in a downstream direction and slalom around sensor. This time, do not wrap the insulation around the body of the O2 sensor. Continue to the wrap until you reach the (DOC)-to-(NAC) flange ([Fig. 3](#)).
