Dealer Service Instructions for:

Emissions Recall G30

Replace Oxygen Sensor Module and Reprogram ECM

2007 - 2008 (DH/D1) Dodge Ram 2500/3500 Pick Up Truck

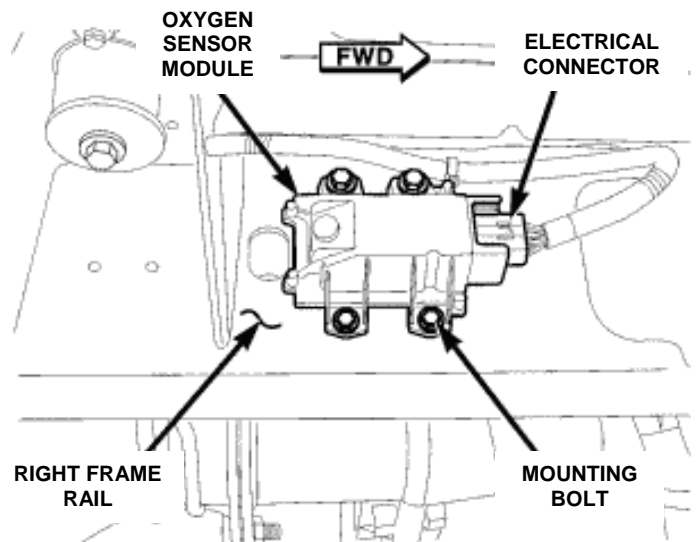
Figure 1

1. Open the hood and disconnect the negative battery cables from both batteries.
2. Using a mechanic's creeper, slide under the right side of the truck and locate the oxygen sensor module on the outer side of the right frame rail (Figure 1).
3. Disconnect the electrical connector at the oxygen sensor module (Figure 1).

4. Remove the four oxygen sensor module mounting bolts (Figure 1).
5. Remove and discard the original oxygen sensor module from frame rail.
6. Position the new oxygen sensor module onto the frame rail.
7. Install the four oxygen sensor module mounting bolts.
8. Tighten the oxygen sensor module mounting bolts to 53 in. lbs. (6 N·m).
9. Connect the oxygen sensor module electrical connector to the module.
10. Connect the negative battery cables.
11. Continue with **Section B - Check ECM Software Level**.
