NUMBER: 23-004-08

Ratcheting Sound During Sunroof Operation

This bulletin involves replacing the sunroof drive cable conduit.

2004 - **2008** (DR)	Ram Truck
**2007 (L2)	300C (China) **
2005 - **2008** (LE)	300C/300C Touring (International Markets)
2005 - 2008 (LX)	300/Charger/Magnum
**2005 - 2008 (WH)	Grand Cherokee (International Markets) **
2005 - **2008** (WK)	Grand Cherokee
**2006 - 2008 (XH)	Commander (International Markets) **
2006 - 2008 (XK)	Commander

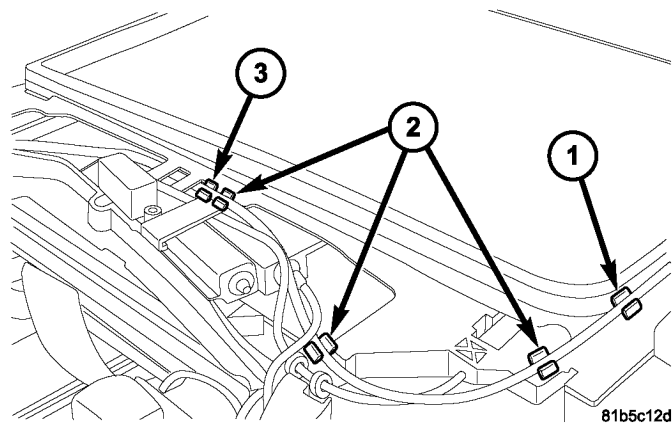
Fig. 1 CONDUIT RETENTION

- 1 - CLIP END
- 2 - RETAINING FEATURES
- 3 - MOTOR END

1. Ensure the sunroof module is in the full closed position.
2. Remove M6 mounting bolts (4) at rear portion of sunroof module.
3. Remove the kinked cable conduit(s) from sunroof module retaining features starting from the end at the metal clip and work back to motor area, see (Fig. 1).

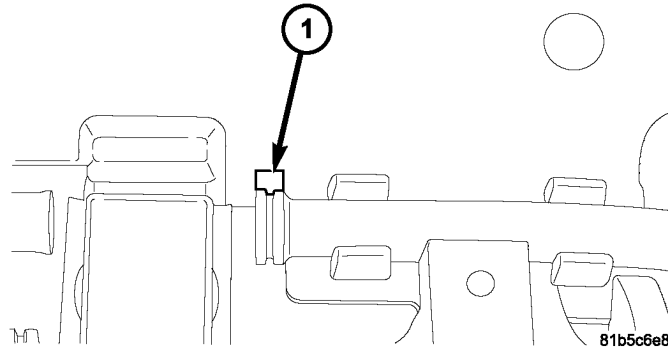
Fig. 2 CONDUIT FLARE INTO NOTCH

1 - LOCATE CONDUIT FLARE INTO NOTCH

-
4. Assemble new cable conduit, p/n 68003812AA, in reverse order of (Step #3) by inserting the flared end over the exposed end of the drive cable. Insure the flared end is sitting in the notch on the rear bulk head of sunroof module, (Fig. 2).

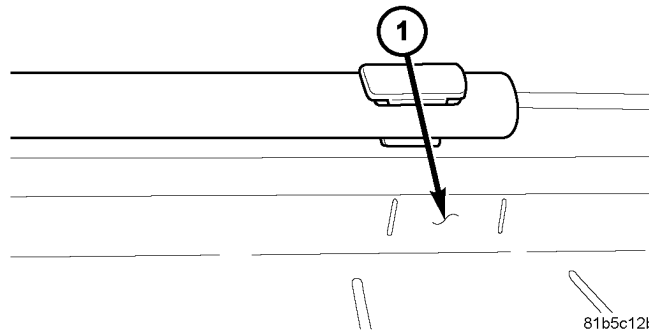
Fig. 3 CLIP TO ALUMINUM GUIDE LOCATION

1 - ENSURE CLIP IS POSITIONED BETWEEN MARKS

5. Snap the cable conduit into the retaining features in the rear bulk head (5 places) with the end of the tube retained in spring clip on the aluminum guide. Ensure the clip is within the provided scribe lines on aluminum guide, (Fig. 3).

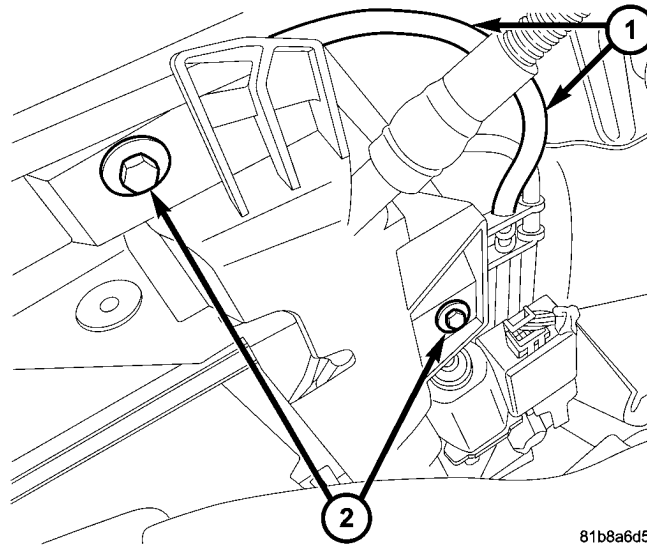
Fig. 4 KINK LOCATION

1. Put the sunroof in the closed or vent position.
2. Drop headliner right front corner, by removing the right side A-pillar trim, B-pillar trim sun visor, sun visor clip and rear view mirror.
3. Look at and/or feel the drive cable conduit in the radius above the drain hose this is where the conduit will be kinked.
4. Remove 2 sunroof mounting fasteners, (Fig. 4).

- 1 - KINK LOCATION
 - 2 - MOUNTING FASTENERS
-

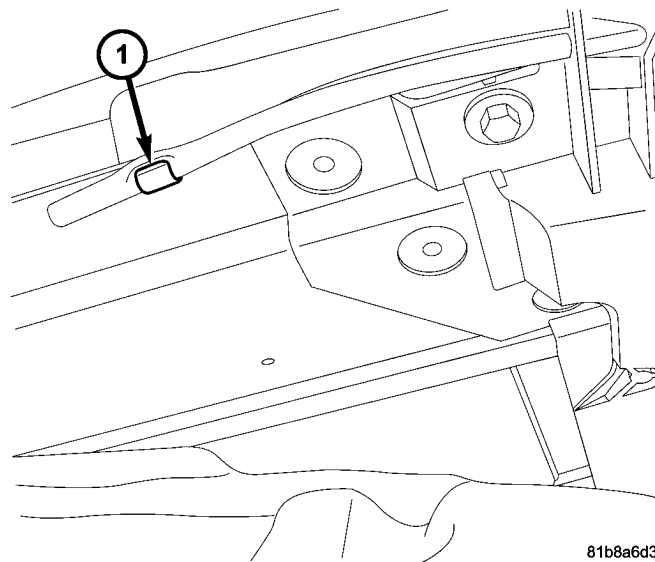
Fig. 5 CONDUIT RETAINER CLIP

- 1 - CLIP
-

5. Remove conduit from clip at side of sunroof module, (Fig. 5).

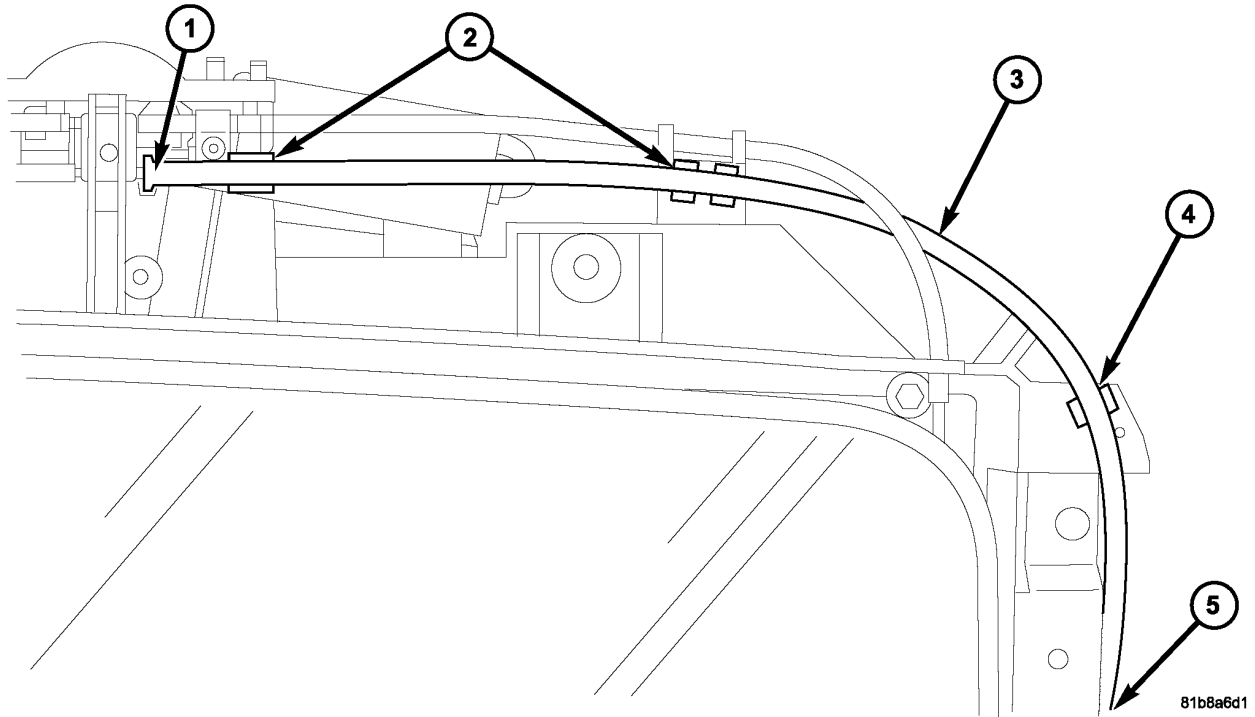
Fig. 6 CONDUIT ROUTING/RETENTION

- 1 - CONDUIT IN NOTCH
- 2 - RETENTION FEATURES
- 3 - CONDUIT
- 4 - FRONT BEAM RETENTION FEATURE
- 5 - CONDUIT CLIP (OUT OF VIEW)

6. Push the conduit up and inboard to release it from the retention feature on the front beam, (Fig. 6) item 4.

-
- 7. Push the conduit up to release it from the additional retention features, (Fig. 6) item 2.
 - 8. Pull the conduit out from over/off the drive cable.
 - 9. Slide the new conduit, p/n 68003816AA, back over the drive cable. See (Fig. 6) item 1, to ensure conduit is seated into notch to the rear of the steel drive cable tube.
 - 10. Secure the conduit in the retention features shown in (Fig. 6).
 - 11. Install the conduit in the side clip.
 - 12. Operate the sunroof to ensure the ratcheting noise is eliminated.
 - 13. Install the mounting bolts.
 - 14. Install the headliner, A-pillar trim, sun visor and visor clip.
